Monitoring Data Record

Project Title: U-3462 Smith Ave. Ext. COE Action ID: 19982173
 Stream Name: Charles Branch and UT to Charles Branch DWQ Number: 20081177
 City, County and other Location Information: Shallotte, NC (Intersection of US 17 Business. (Main St.) and Smith Ave.
 Date Construction Completed: Streambank Reforestation completed January 2012
 Monitoring Year: (3) of 5
 Ecoregion: _____ 8 digit HUC unit 03040207
 USGS Quad Name and Coordinates: Shallotte 33.979506, -78.377487

Charles Branch Stream Mitigation Site

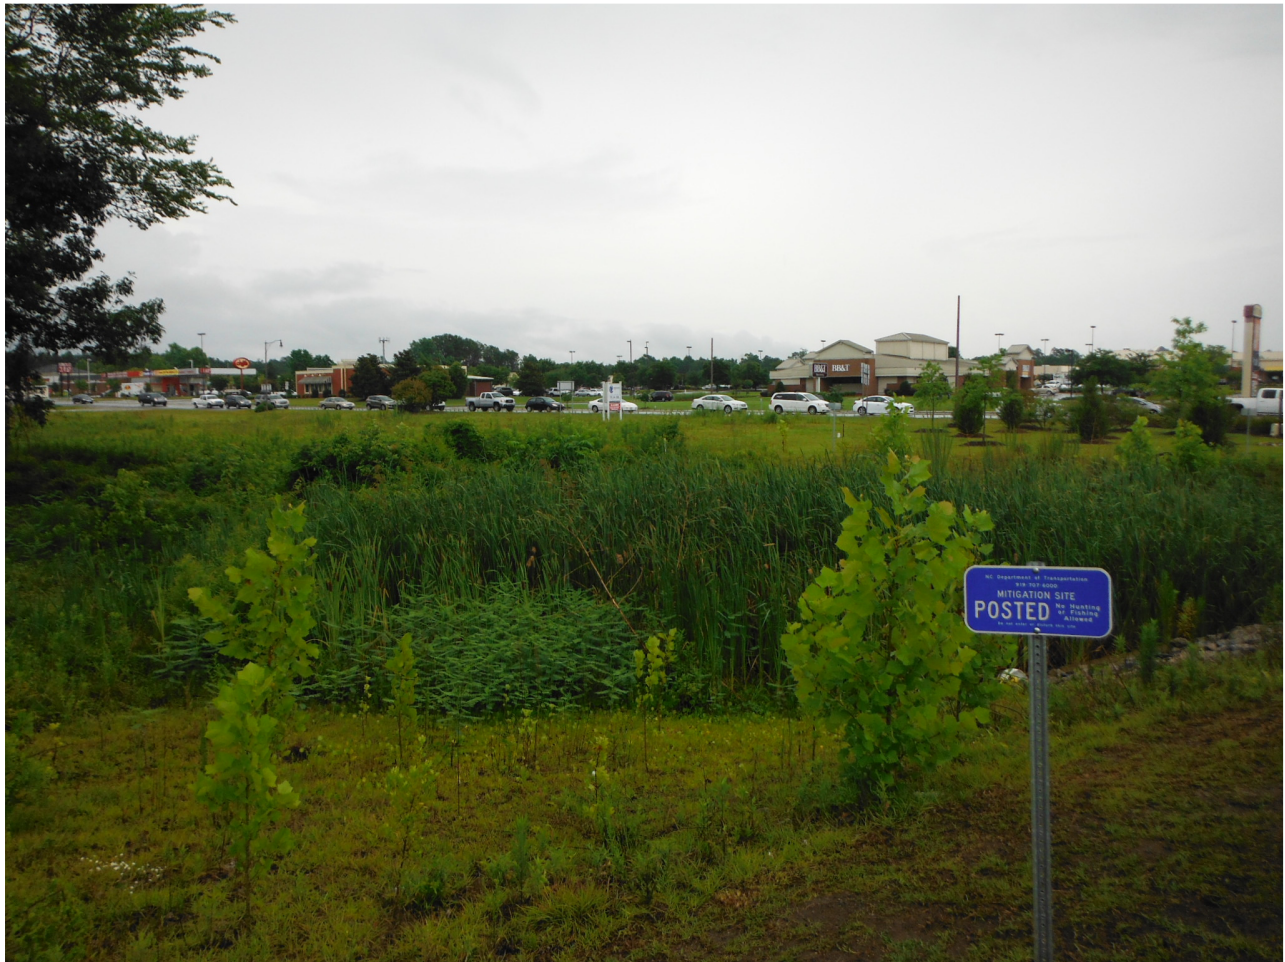
Buffer overview at PP#1
